# BIRD STRIKE MONITOR

**CALIFORNIA  
ENERGY  
COMMISSION**

P500-97-010

**Sheila Byrne  
Technical and Ecological Services  
PACIFIC GAS AND  
ELECTRIC COMPANY**

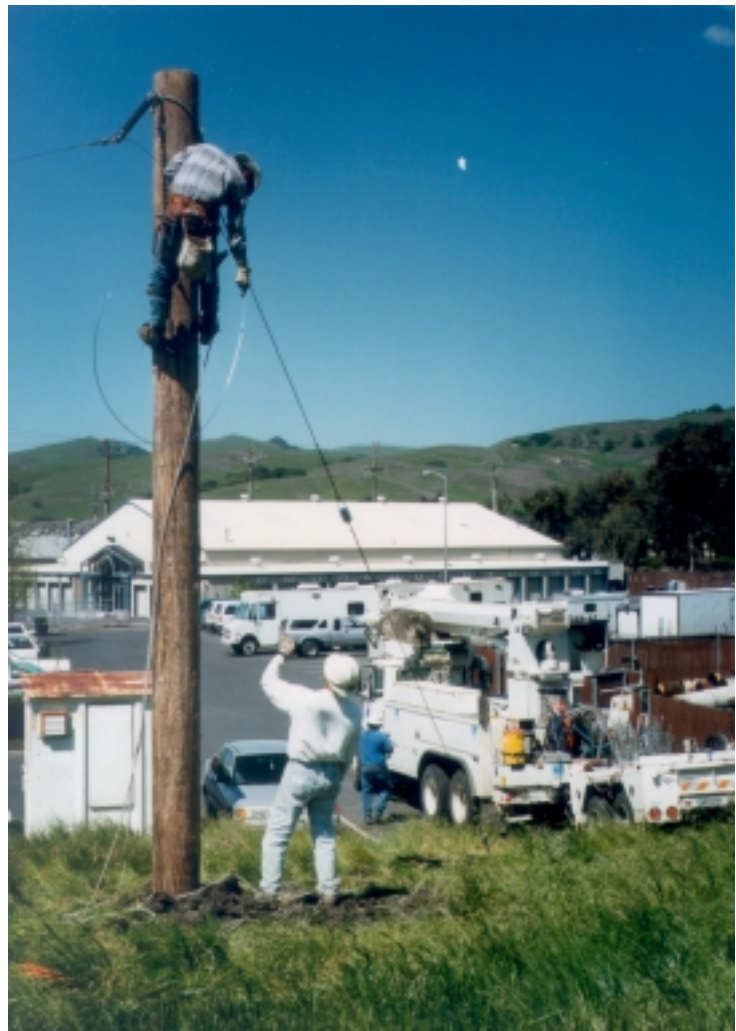
Figure 3. Installing Test Line

Pacific Gas and Electric Company's General Construction line men built a single conductor test line for the bird strike monitor at TES (Figure 4). We consulted with distribution engineers and linemen to determine the most typical spans, materials, and tensions. The test line was constructed to their specifications at a convenient height. The conductor is #4 ACSR, 300 feet in length, and tensioned by sag to specifications.

For testing, a monitor can be mounted at any point on the line. We placed the ground station, outside the laboratory building and connected it to an analog modem line and household current through a power converter. Data was accessed by dialing in with a computer through another analog modem line using a custom program, (BIRDSTK) on any simple communications program. An independently operated video camera was mounted on a tripod to capture strikes on film. Because the old battery packs had been taken out and thrown away in 1996, the monitors were powered from an external power supply, a 12-volt automobile battery, until we built new custom battery packs. The first set used sulfur dioxide lithium batteries. Later, a second set of custom battery packs was prepared from lithium thionyl chloride batteries, used in the original monitors, in an attempt to correct data transmission problems.

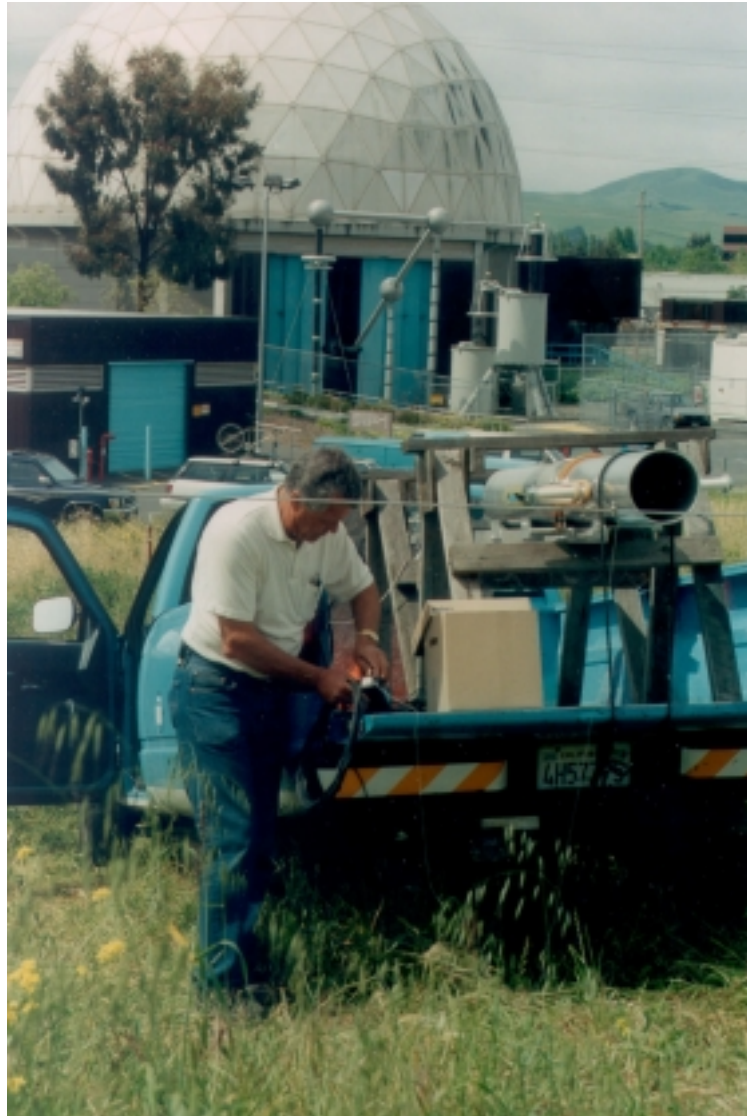
**Figure 4. Bird Cannon Ready to Fire**

TES technicians constructed a bird cannon (Figure 5). It is a mechanical device designed to propel dead birds at velocities appropriate for testing (10 - 50 miles per hour). Accelerometers were placed in the pan of the cannon and on the line, and connected by cable to an HP 35670A dynamic signal analyzer to provide additional sample velocity checks. The cannon was mounted on the back of a pickup to allow easy positioning in relation to the test line.

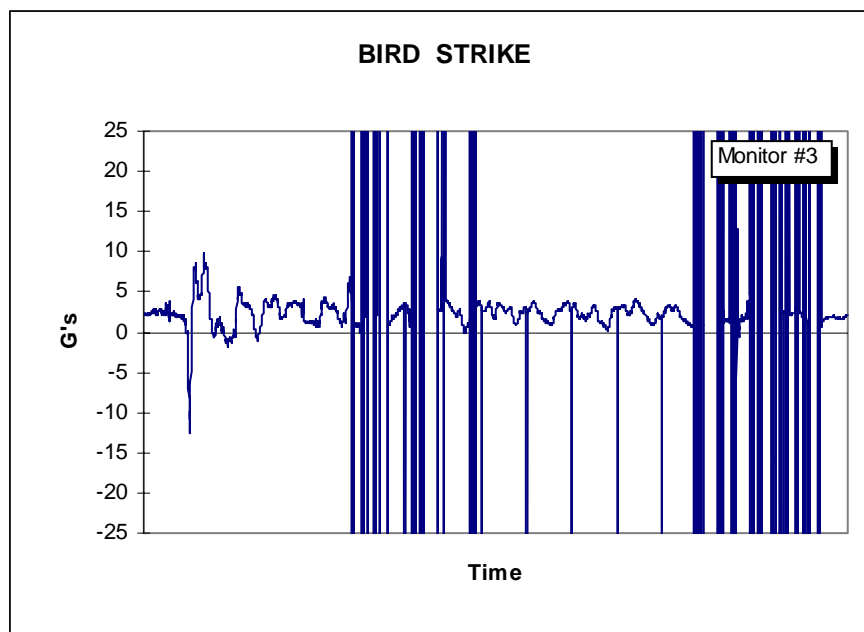
**Figure 6. Waveform Produced by Corrupted Data**

Comparison of Figure 6 with Figure 7, two typical graphs produced by corrupted data, shows the problem we encountered. A force of over 3,000 pounds was recorded, approximately two orders of magnitude greater than a bird could generate. When the scale of Figure 7 is expanded, it shows a reasonable waveform initially, but the last two-thirds of the data file is corrupt. The large peaks are spurious. A close examination of the data files in binary form shows that the corruption results from loss of data. Loss of a single bit can cause an effective reversal of the hi-byte lo-byte sequence, with the same effect as reversing units and tens digits. Small numbers turn into very large numbers.<sup>1</sup> During these initial tests only 25 percent of the data were usable. The rest showed corruption, or did not record files on the ground station.
